NAVAER 00-75-510

THE NAVAL AVIATION SAFETY REVIEW

VOLUME 5

NUMBER 3

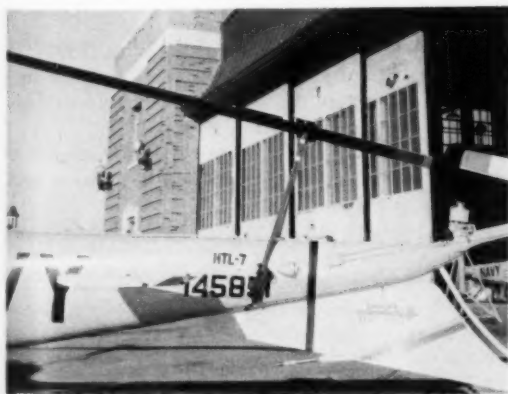
BLADE SECURING—An HTL-7 was being towed by tractor into hangar when the main rotor blade struck side of hangar. One main rotor blade buckled approximately 5 feet from tip (see photo). The main rotor head had to be replaced due to sudden impact.

The main rotor blade mooring block slipped off

the main rotor blade permitting the blade to rotate while the aircraft was being towed.

The cause of this accident is directly attributed to the method in which the rotor blade securing strap was attached to the aircraft, which was in accordance with the HTL-7 Handbook of Maintenance Instructions.

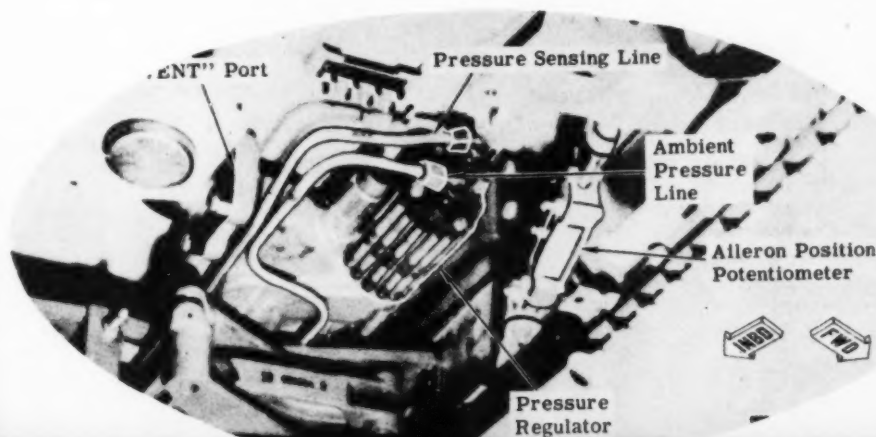
This accident is a perfect example of Murphy's Law in that two lines of the same size with identical fittings are connected in close proximity in a half blinded area. It is recommended that fittings of a different size be used on both ends of one of these two lines and the associated connections on the regulator and at the bulkhead. This would make it impossible to cross-connect the two lines.

A service change correcting this design deficiency was recommended to BuAer. ●
